Response to Goldenrod Blue Report on Brooklyn Bridge Park Preventative Maintenance Plan

PREPARED FOR: David Lowin
PREPARED BY: Erika Gorman
DATE: March 22, 2016

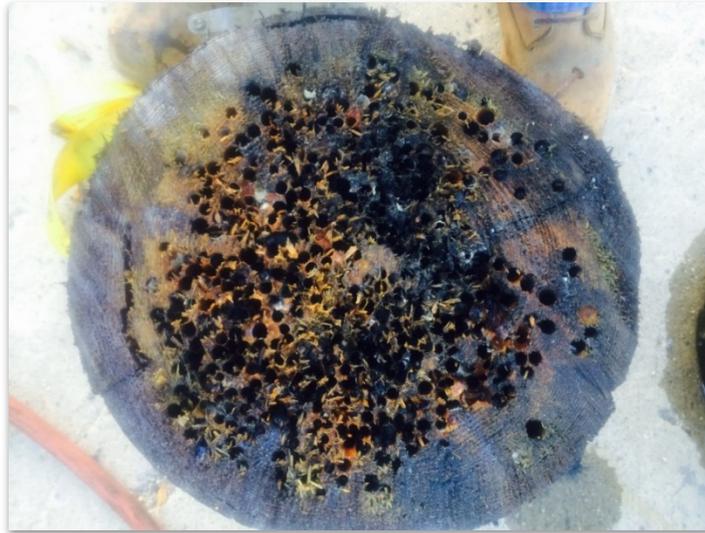
not equate to timber section loss. Creosote is a preservative compound in the pile, its loss only opens the pile to greater risk of invasion by borers. As shown in Photo 1, which was included in the CH2M report, the creosote treated timber piles are already under attack from marine borers. It is noted that even if a pile were to be fully creosoted at the recommended level, it is still susceptible to a particular type of marine borer known as teredo due to inevitable imperfections or breaches in the creosote treatment. Teredo attacks the pile by burrowing into the timber pile surface at these points of weakness and begin eating the interior of the pile (which is not treated) while leaving the treated surface untouched. The creosote testing performed by Wood Advisory Services in 2010, and detailed in the CH2M report, demonstrated that all Piers have level of creosote below the 8.0 pcf threshold recommended by the American Wood Protection Association (AWPA) for the protection of piles. The only point correctly demonstrated by the GB study, is that the level of creosote in the timber piles will continue to decrease each year, below the already ineffective level of protection. This is in agreement with CH2M's assessment. This does not demonstrate the option to delay maintenance of these structures, whether preventative or structural.

Regardless of the creosote retention methodology presented in the GB report and the projected year of "pier degradation", which GB wrongly interprets to be equivalent to when the creosote reaches an assumed minimum threshold, it is clear from CH2M's inspection of the piers that the timber piles are already susceptible to marine borer attack at the current creosote levels.

Photo 1
Marine Borer Attack on Pile at Pier 3
